# CASE STUDY

Complete mechanical and cosmetic refurbishment of a Dieci F7000 concrete re-mixer to return the unit to full operational condition and extend service life.

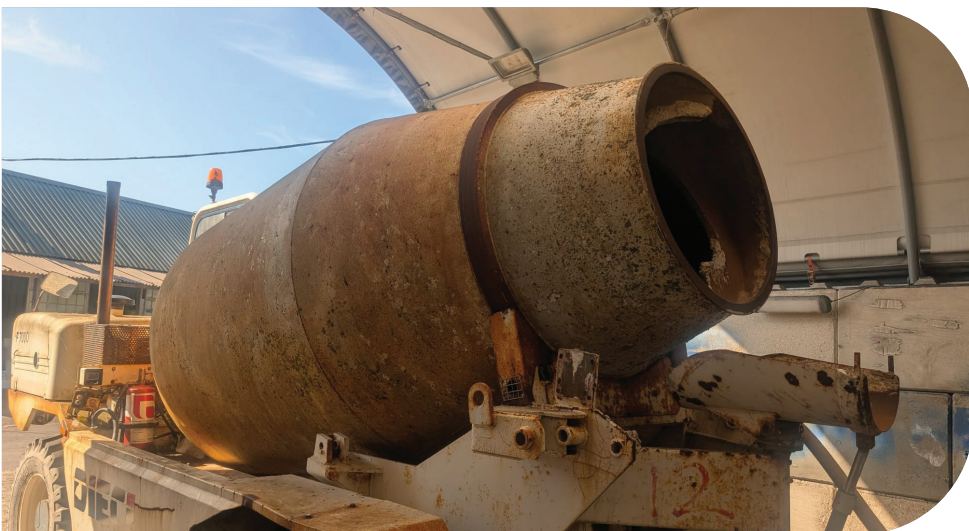
The entire machine had extensive corrosion. We decided not to remove the mixer drum as the process posed significant safety risk as well as a huge amount of time and labour. Instead, we carefully prepped the machine by removing many ancillaries and protected all remaining parts of the machine which did not require grit blasting. We then grit blasted the entire structure back to bare metal.
