SHOTCRETE

CASE STUDY

Shotcrete was contracted to carry out five trial repairs on the perimeter barriers that also support the footpaths within the West Dartford Tunnel.

Dartford Tunnel West

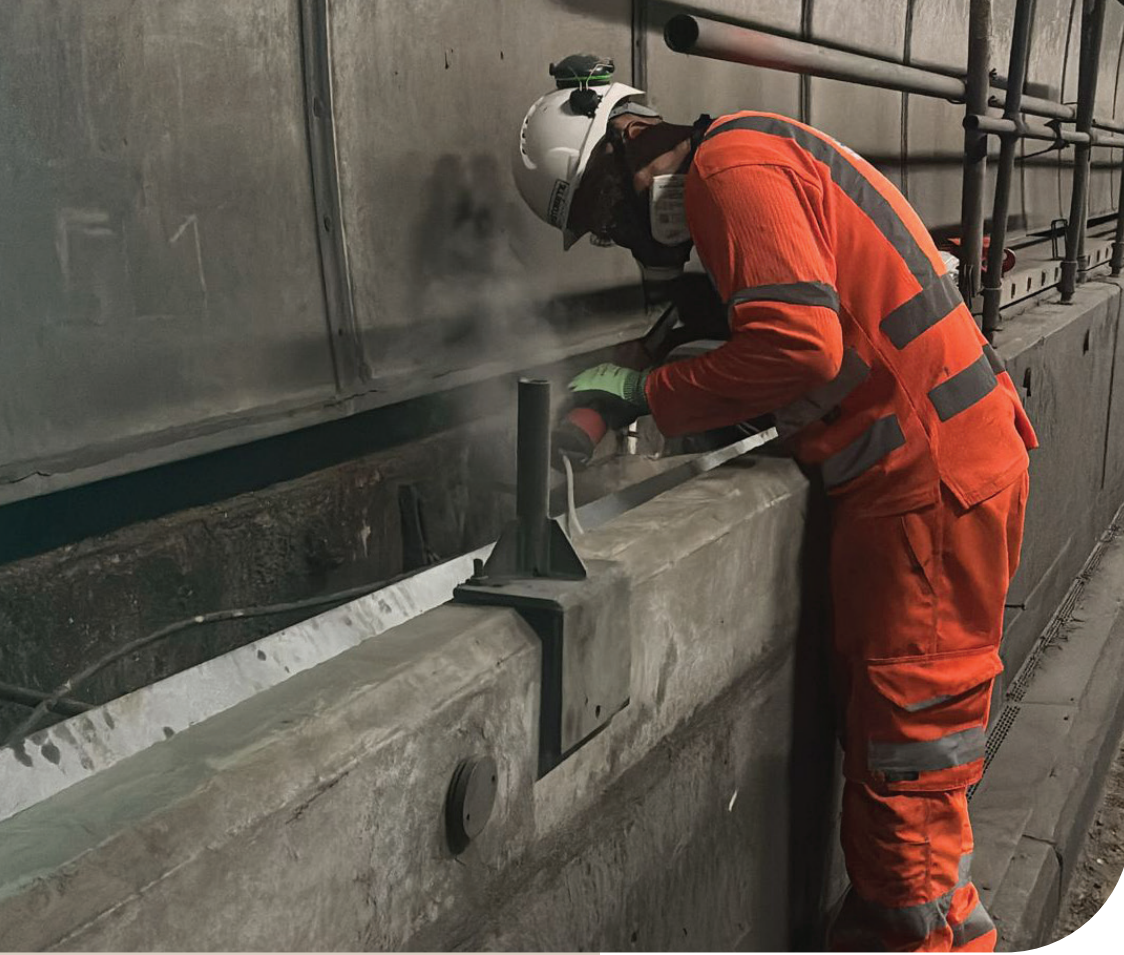
MATERIALS USED

- ✓ Concrete/grout used for this job was LA55 and LA60.
- ✓ Epoxy used was Hilti resin.
- ✓ Steel was 12mm diameter rebar.

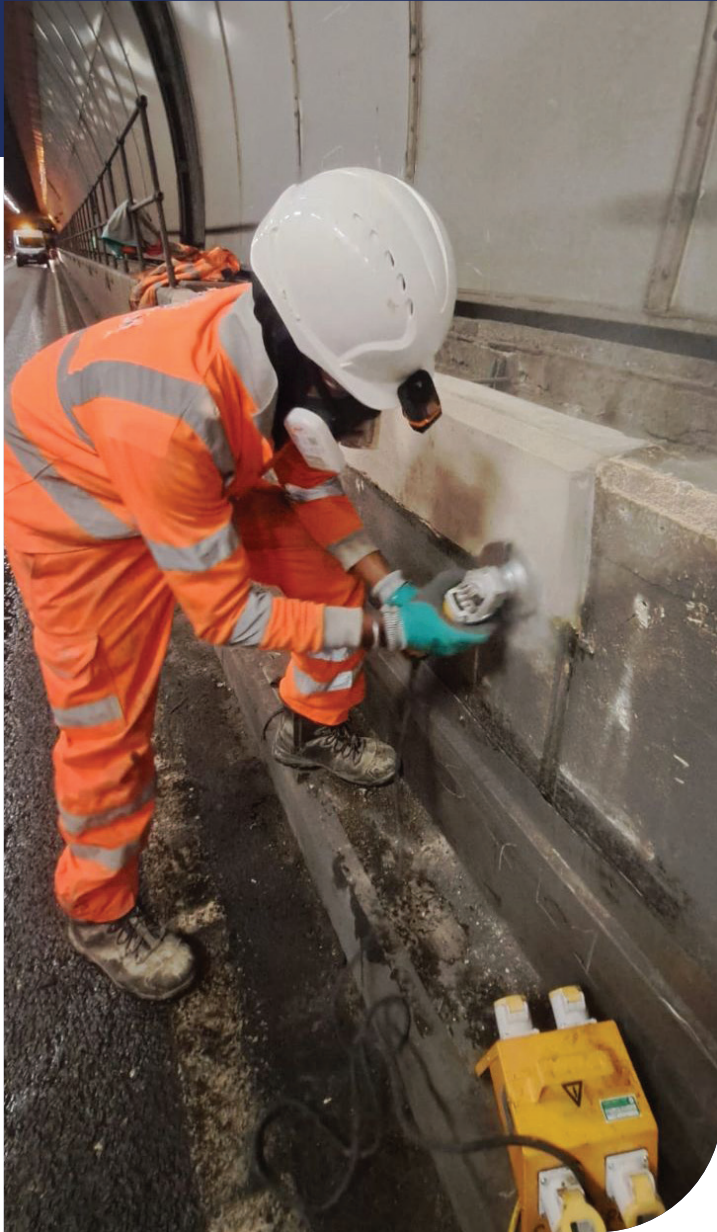
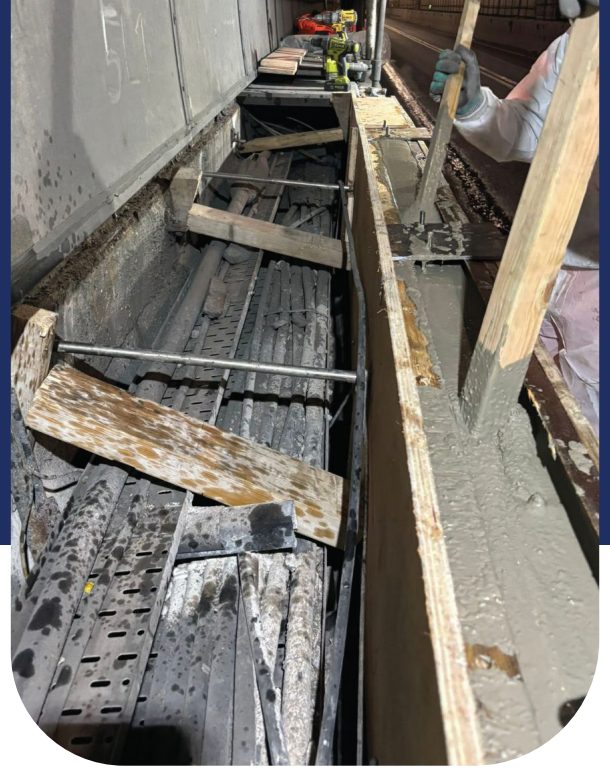
The job began with the removal of the top section of the old panel, followed by saw-cutting and removal of the first two panels. The client required the remaining three panels to be locally broken out around areas of defective concrete.

The next phase involved work on the steel reinforcement. Replacement steel was installed, and anodes were added to help extend the design life of the repaired panels.

Once the steel was in place, it was primed, and the repair areas were shuttered. This included forming a step at the back and creating joints along the sides to ensure a clear separation between the new and existing concrete.

After pouring the new concrete, holes were drilled to allow for the installation of additional components using epoxy, further enhancing the durability and design life of the panels.
