SHOTCRETE

CASE STUDY

The restoration of Madeira Terrace in Brighton is one of the most significant heritage regeneration projects underway in the UK. The Victorian cast-iron structure – an iconic seafront landmark – has suffered decades of coastal weathering and required major structural intervention. Phase 1 focuses on the restoration of 28 arches, upper deck renewal, accessibility improvements, and green wall reintegration.

Shotcrete Services Ltd (SSL) were engaged to deliver specialised sprayed concrete and soil nailing works essential to stabilising, reinforcing, and re-facing critical structural areas.

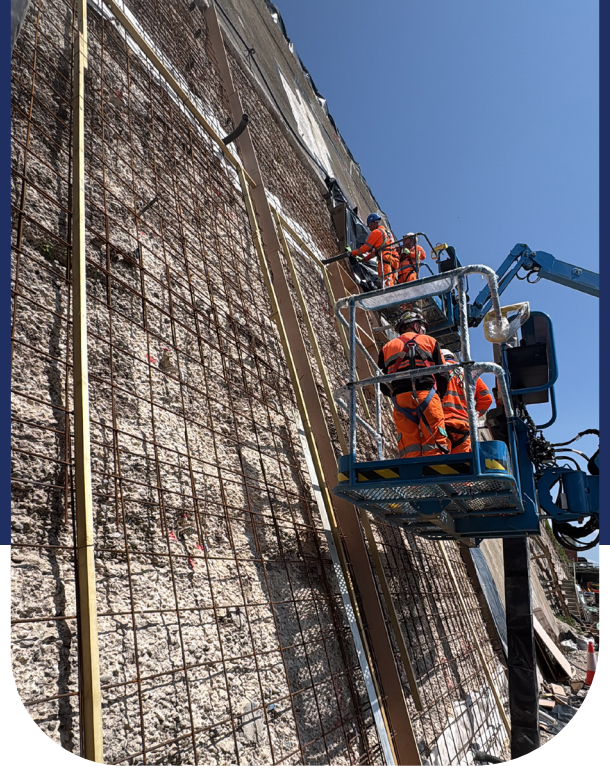
Construction joints were positioned to accommodate staged working and interface with existing wall sections not part of the renovation works.

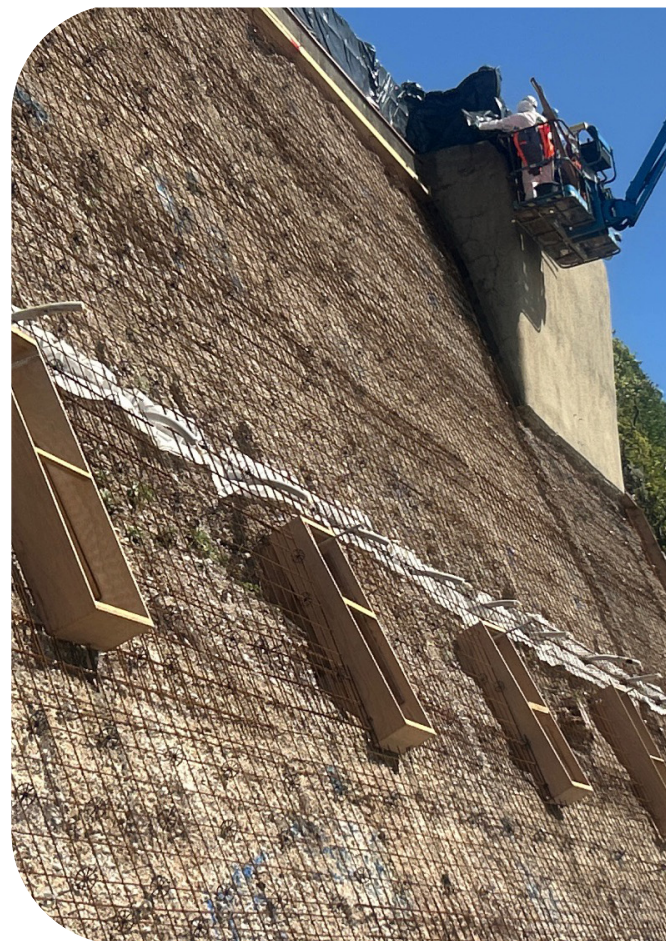
Movement joints were installed to manage thermal expansion, natural deflection, and long-term movement of the coastal structure—protecting the integrity of the new sprayed concrete finishes.
