# CASE STUDY

Complete mechanical and cosmetic refurbishment of a Dieci F7000 concrete re-mixer to return the unit to full operational condition and extend service life.

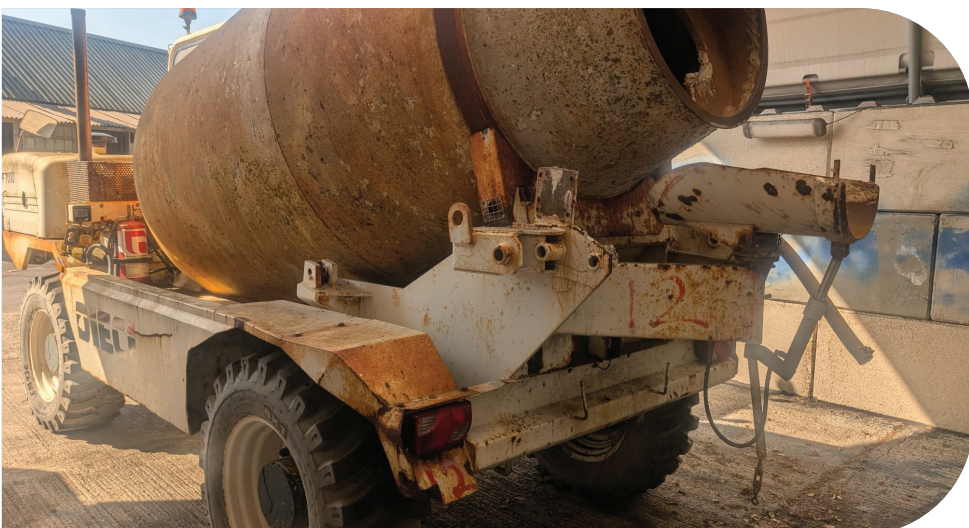
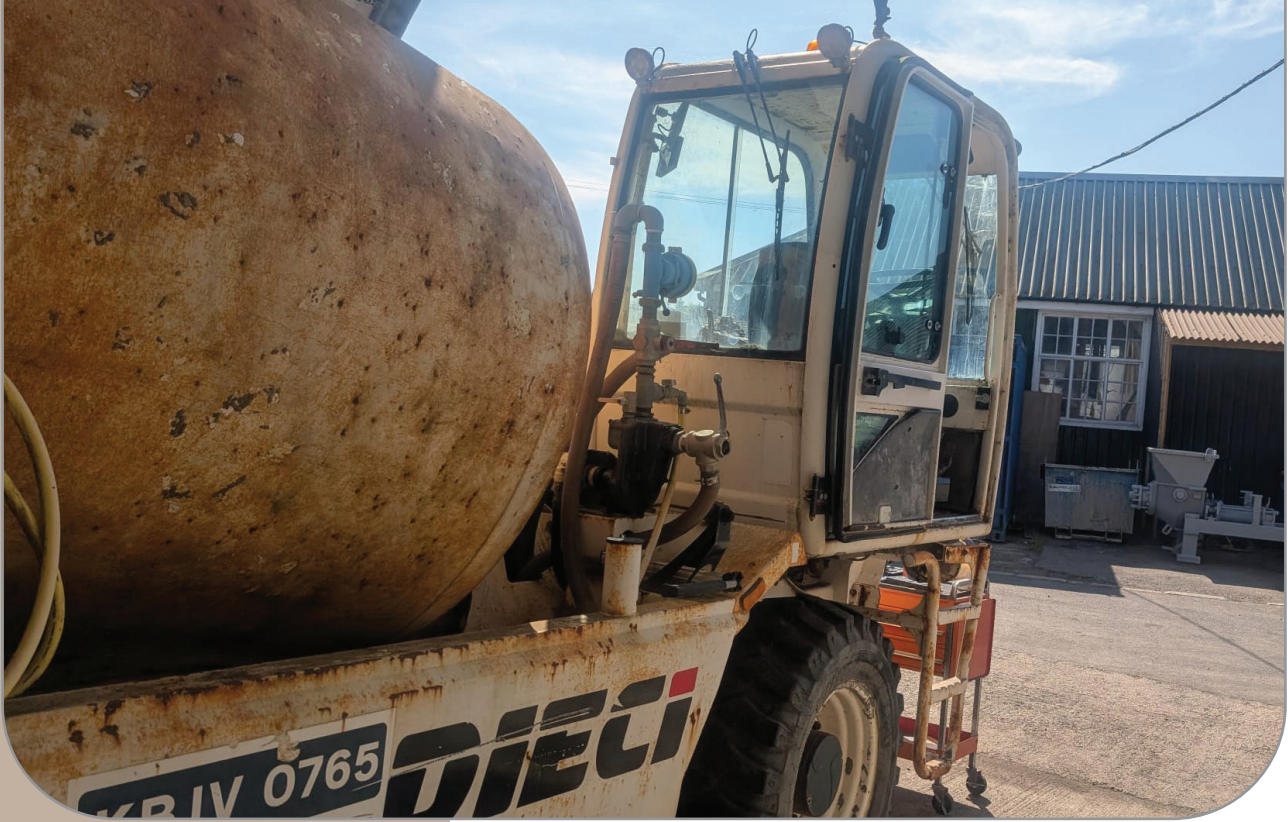
The entire machine had extensive corrosion. We decided not to remove the mixer drum as the process posed significant safety risk as well as a huge amount of time and labour. Instead, we carefully prepped the machine by removing many ancillaries and protected all remaining parts of the machine which did not require grit blasting. We then grit blasted the entire structure back to bare metal.

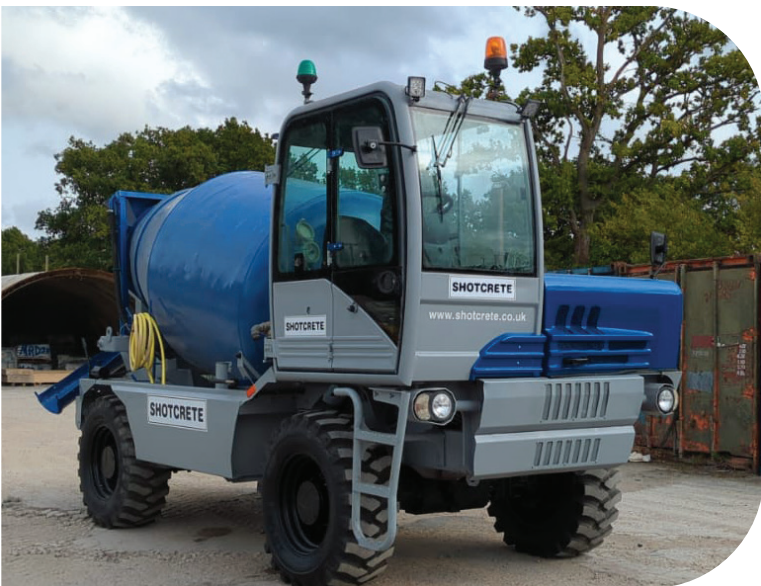
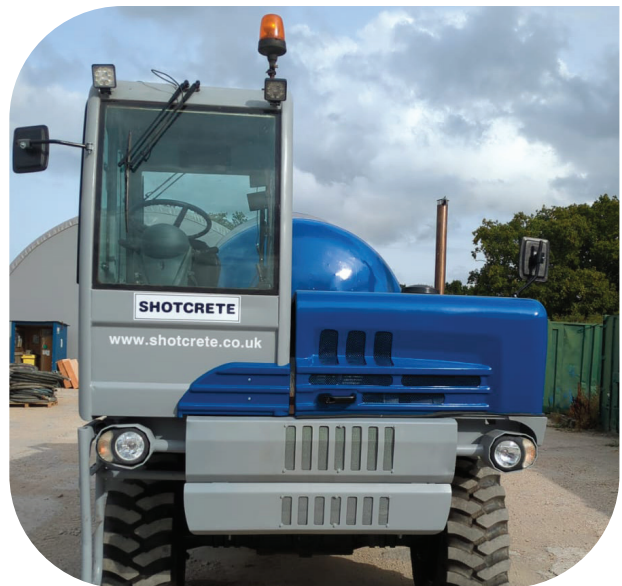
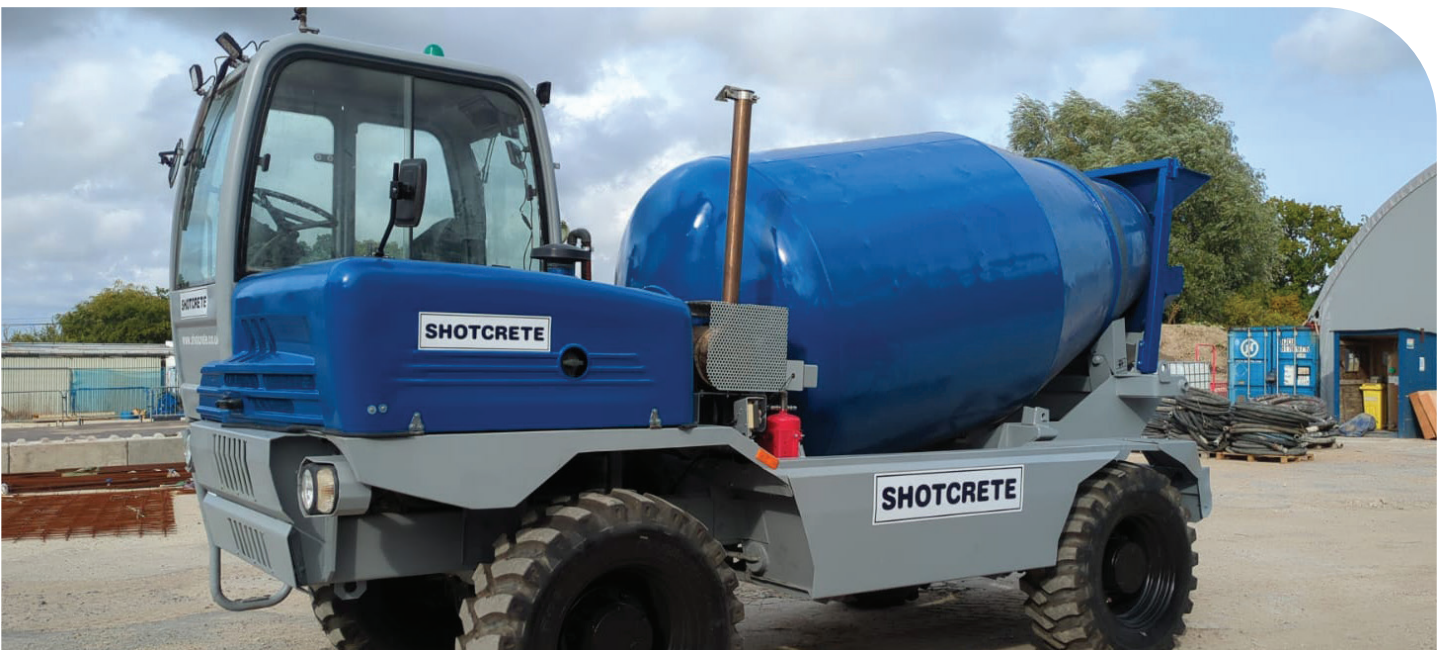
The 12-week refurbishment programme, completed on schedule in August 2025 with a successful outcome. All identified mechanical and electrical faults were systematically diagnosed and rectified, with particular attention to the previously inoperative high/low range selection and recurring DPF regeneration issues – both now fully resolved with no fault codes present.

The fibreglass bonnet has been structurally repaired, reinforced, and finished to a high standard.

A complete strip-down and professional re-spray has restored the machine's appearance to near-new condition.

Following final commissioning and extended load testing, the Dieci F7000 has been returned to service in full working order, significantly improved performance, and a markedly enhanced aesthetic and resale value.
